NATIONAL PROGRAM FOR INSPECTION OF NON-FEDERAL DAMS
MILTON THREE PONDS DAM (U) CORPS OF ENGINEERS WALTHAM
MA NEW ENGLAND DIV AUG 78

REPORT DOCUMENTATION PAGE		READ INSTRUCTIONS BEFORE COMPLETING FORM
1. REPORT NUMBER NH 00320	2. GOVT ACCESSION NO.	3. RECIPIENT'S CATALOG NUMBER
4. TITLE (and Subtitle) Milton Three Ponds Dam NATIONAL PROGRAM FOR INSPECTION OF NON-FEDERAL DAMS		5. TYPE OF REPORT & PERIOD COVERED INSPECTION REPORT

Figure 1 - Overview of Milton Three Ponds Dam.

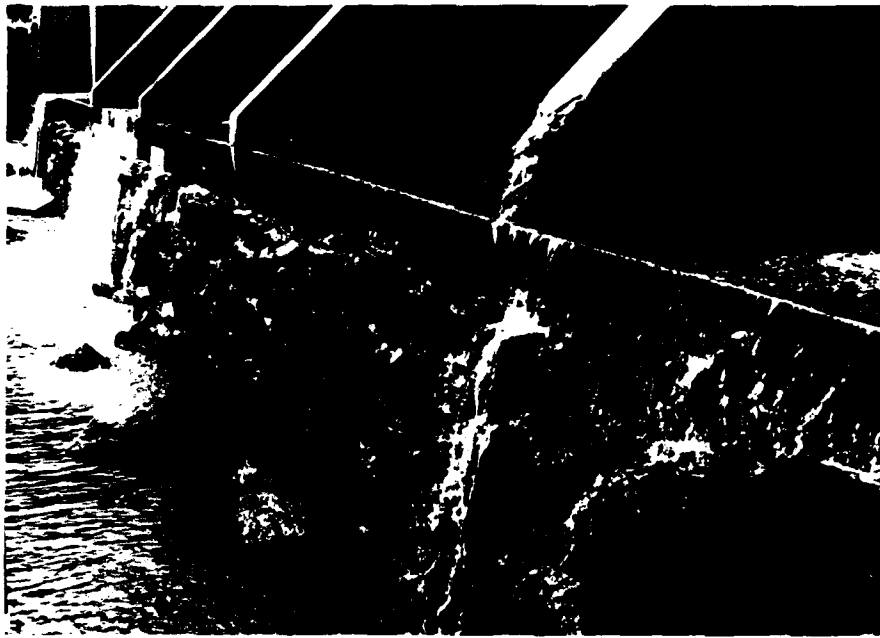
The most severe deterioration of the counterfort wall has occurred on the first wall from the left abutment. Approximately 3 inches of the downstream end of the toe of the wall has spalled. (See Appendix C - Figure 8.) Minor loss of surface laitance has occurred on the counterfort walls and spillway apron where the concrete is in continuous contact with the water, exposing some of the coarse aggregate. Evidence of undercutting was noted at the joint between the bottom of the counterfort wall and the base slab. However, the visual inspection could not determine the depth of undercut or effect on the vertical wall reinforcing.

Figure 8 - Close-up view of the downstream face of the dam. Note the spalling on the nearest countefort.

(1) Repair annually and maintain the structure to eliminate the effects of cracking, spalling, erosion, and loss of surface laitance of the concrete, and rusting of the stoplog angle irons.
